PESCADERO-BUTANO WATERSHED ASSESSMENT

Final Report

March 5, 2004

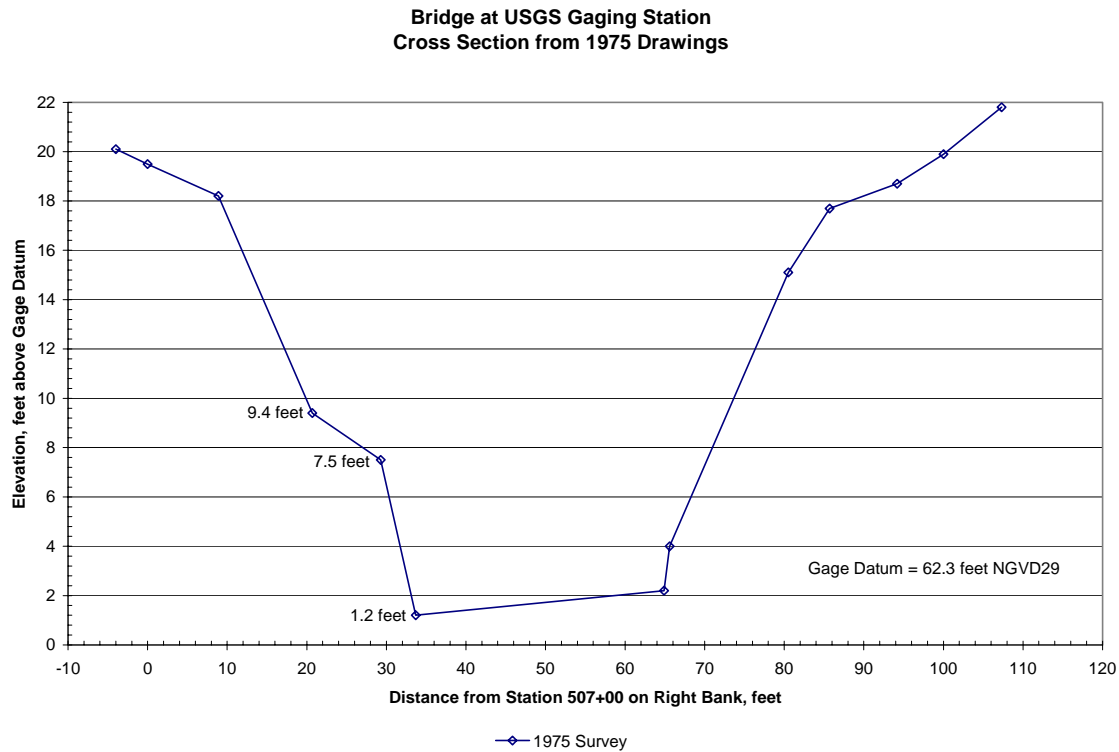
Figure 4-1: The above graph shows the channel cross section at the USGS gauge in 1975. The elevations shown on the graph have been converted into gauge heights. The elevation of the gauge datum is 62.3 feet.

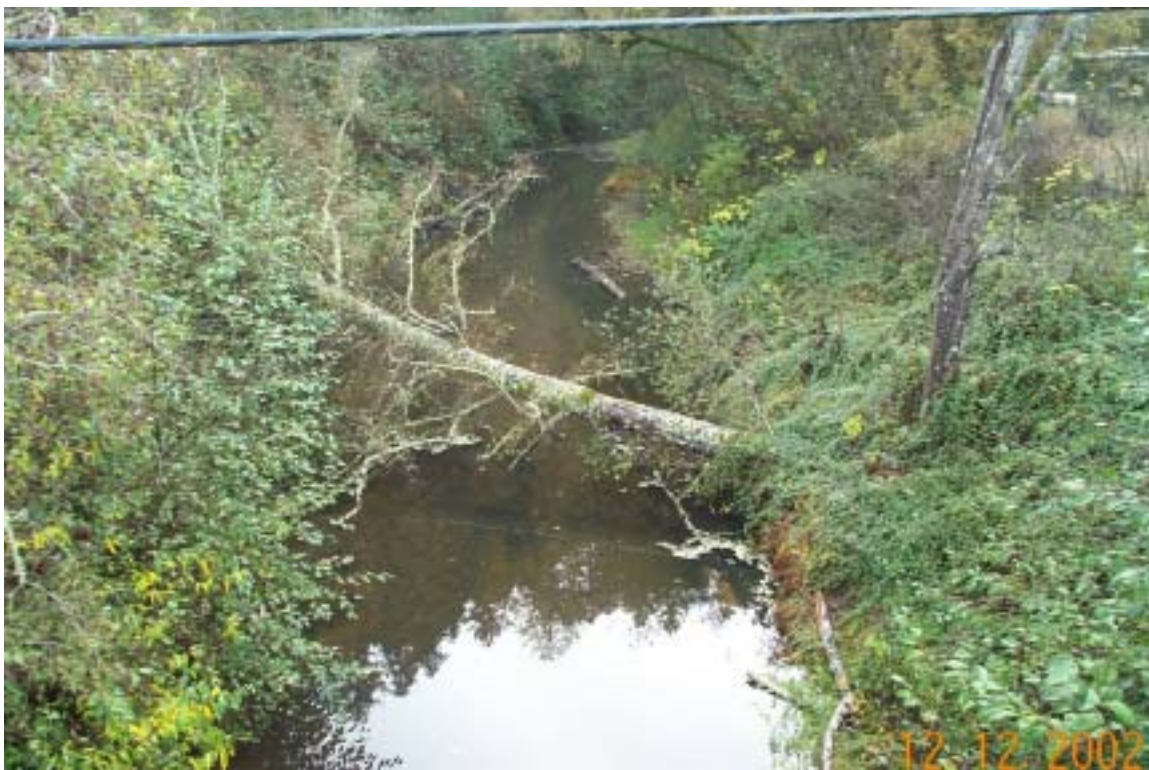
Figure 4-2: Photograph of Pescadero Creek just downstream of the USGS gauging station, taken from the Pescadero Road bridge.

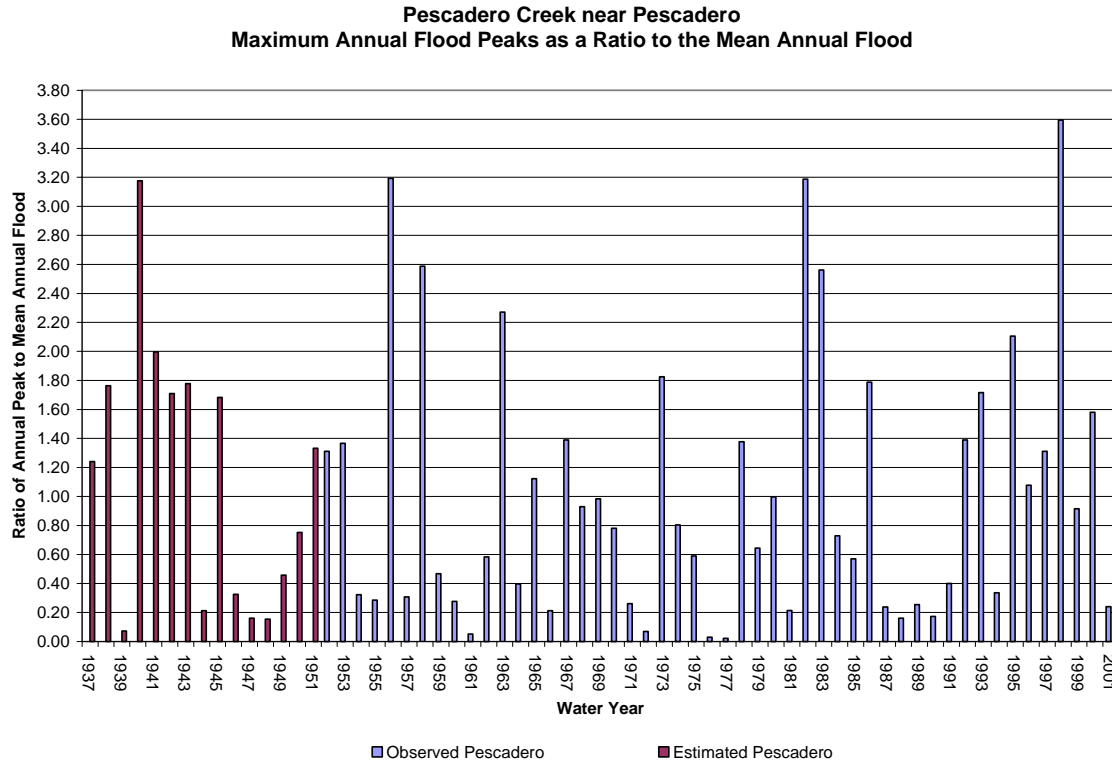
Figure 4-3: The annual maximum peak discharges for the USGS station, Pescadero Creek near Pescadero, are expressed as a ratio to the mean annual flood. Earlier peaks were estimated using the San Lorenzo River at Big Trees record.

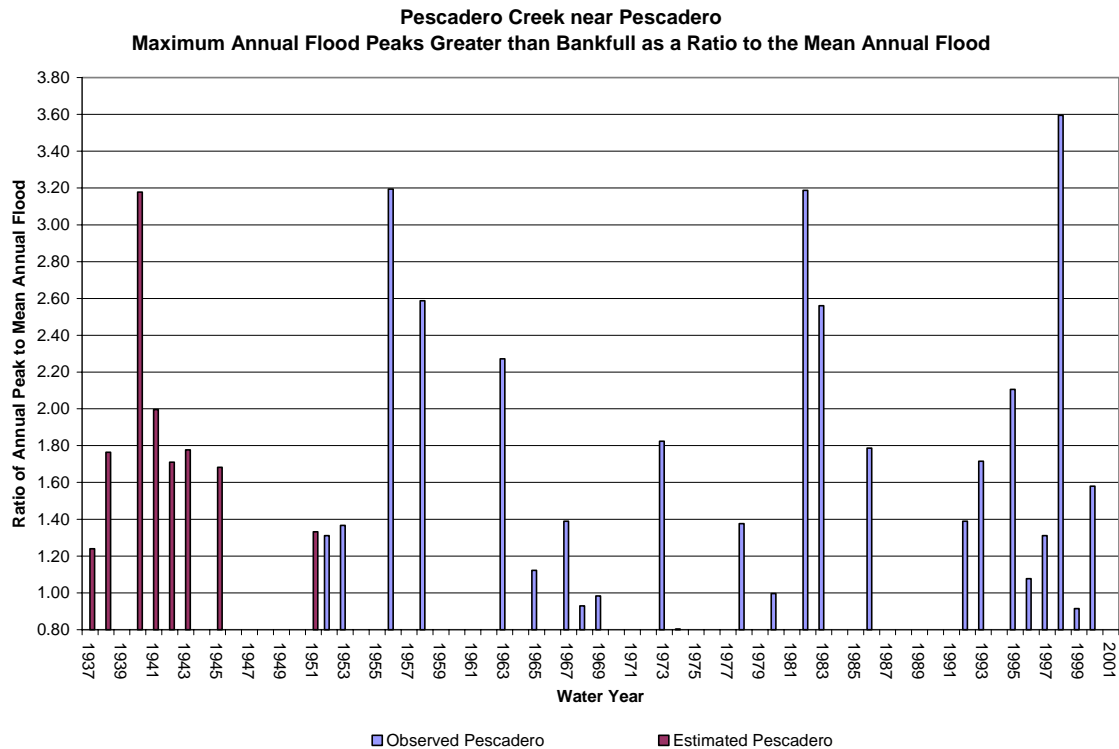
Figure 4-4: The annual flood series is shown with only the annual peaks larger than the estimated bankfull discharge of 0.8 times the mean annual flood.

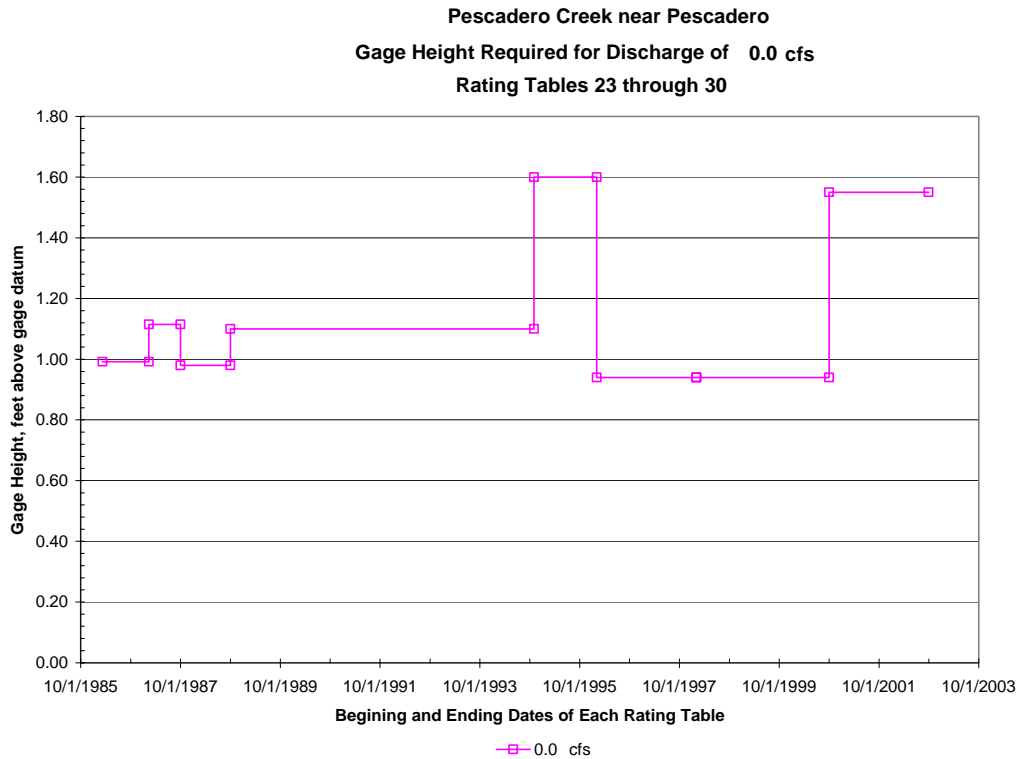
Figure 4-5: The above graph shows the gauge height for the flow cessation point for 1986 – 2002.

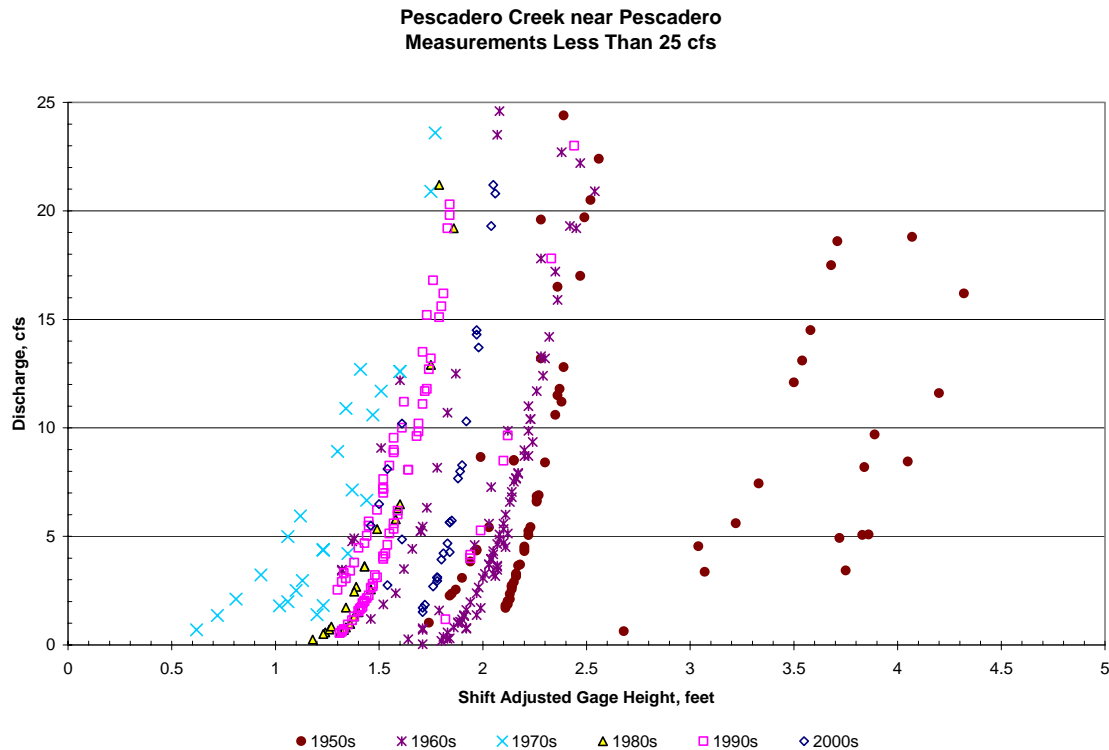
Figure 4-6: The discharge measurements less than 25 cfs for Pescadero Creek near Pescadero are shown above.

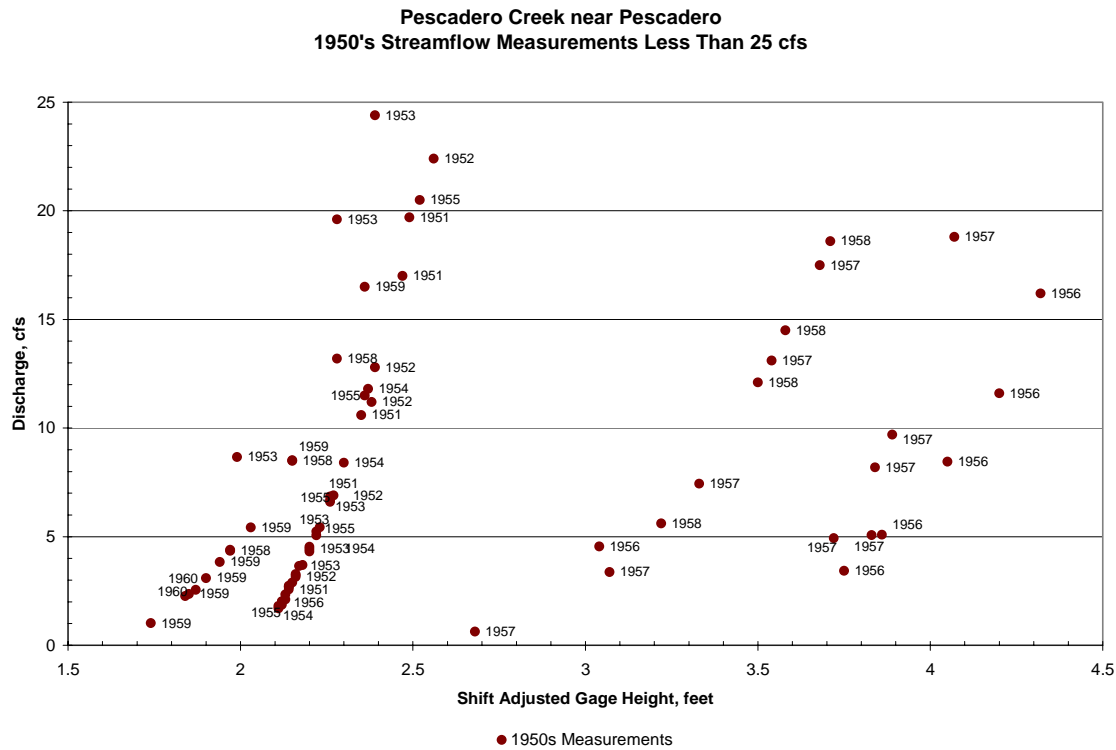
Figure 4-7: The discharge measurements less than 25 cfs for only the 1950s are shown above. The labels, adjacent to the data points, indicate the water-year of the measurement. Note that the gauge height scale begins at 1.5 and ends at 4.5 when comparing Figure 4-7 with Figure 4-6.

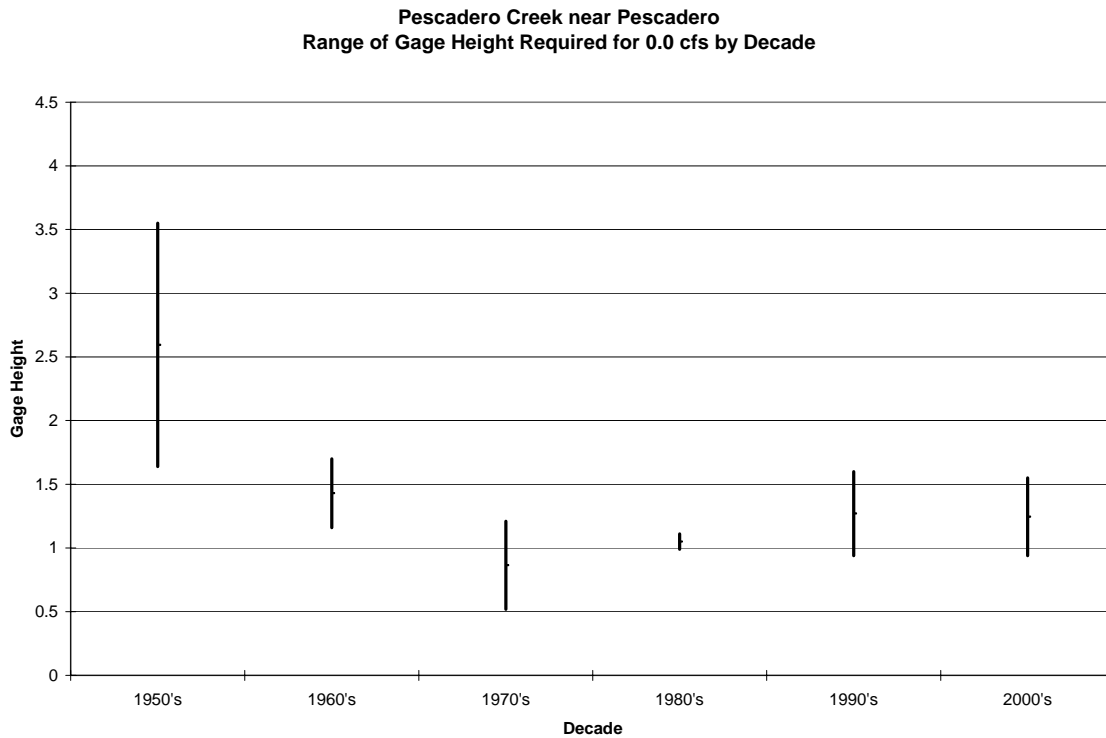
Figure 4-8: The range of the gage height for the point of zero flow, by decade, is shown in the above graph.

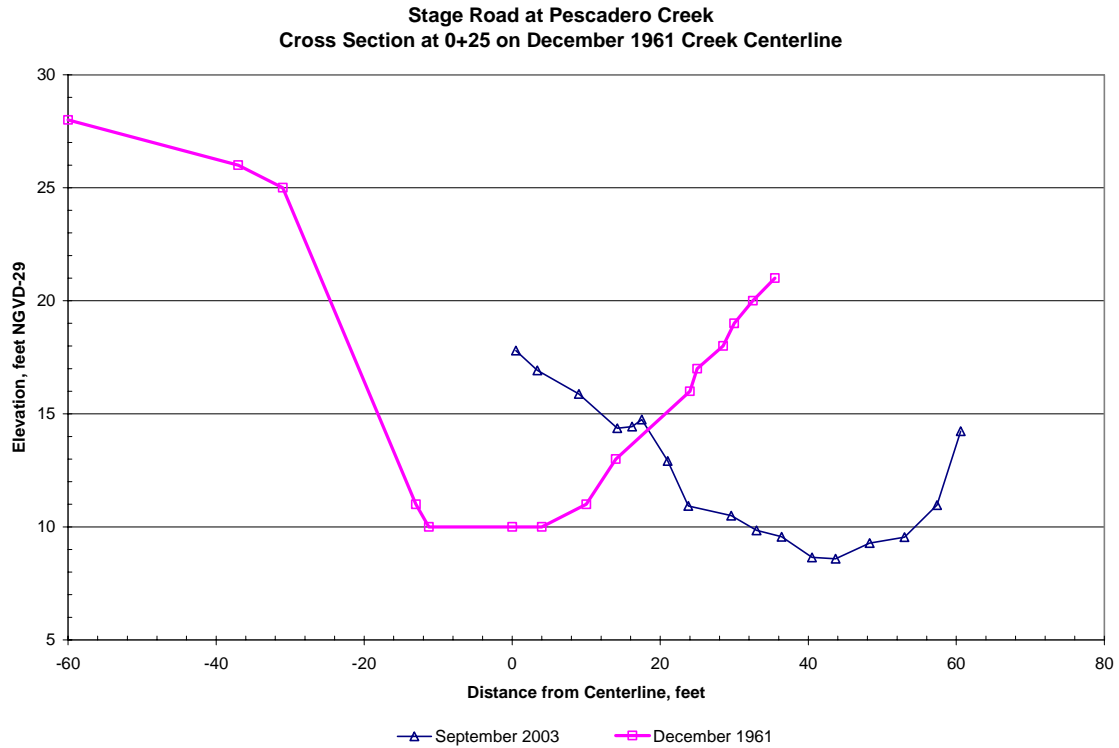
Figure 5-2: The graph of the cross section at Station 0+25 shows the apparent channel migration upstream of the Stage Road Bridge over Pescadero Creek.

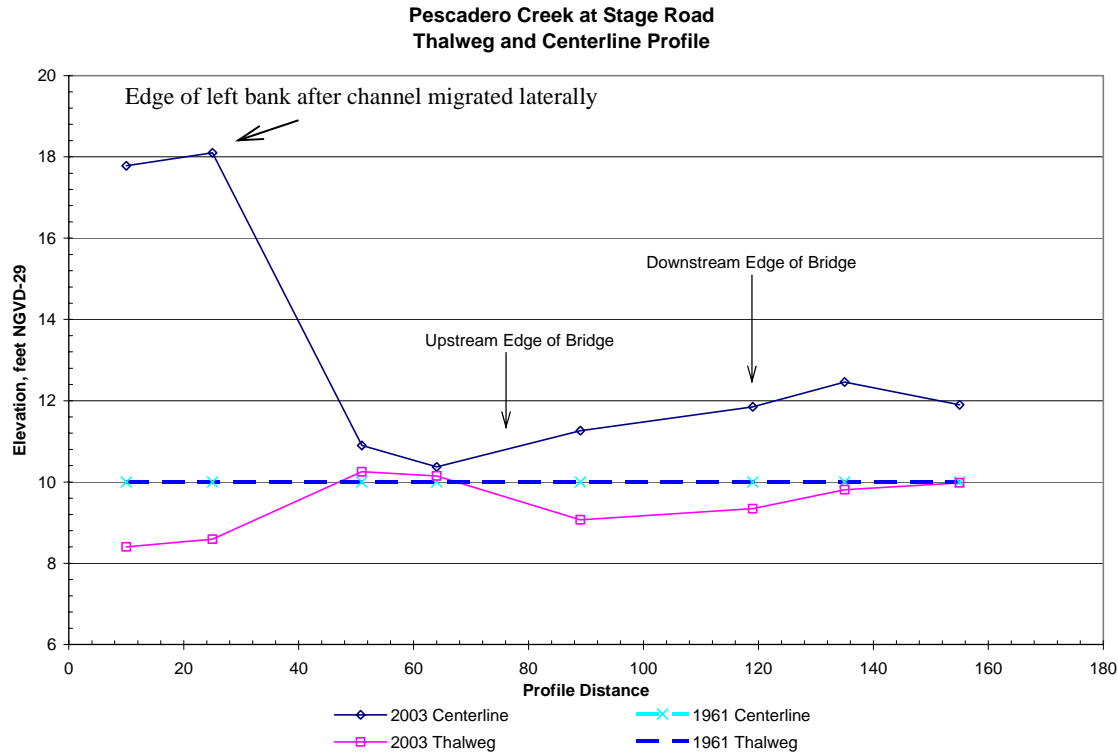
Figure 5-3: The graph shows the change in the centerline and thalweg profiles of Pescadero Creek under the Stage Road Bridge.

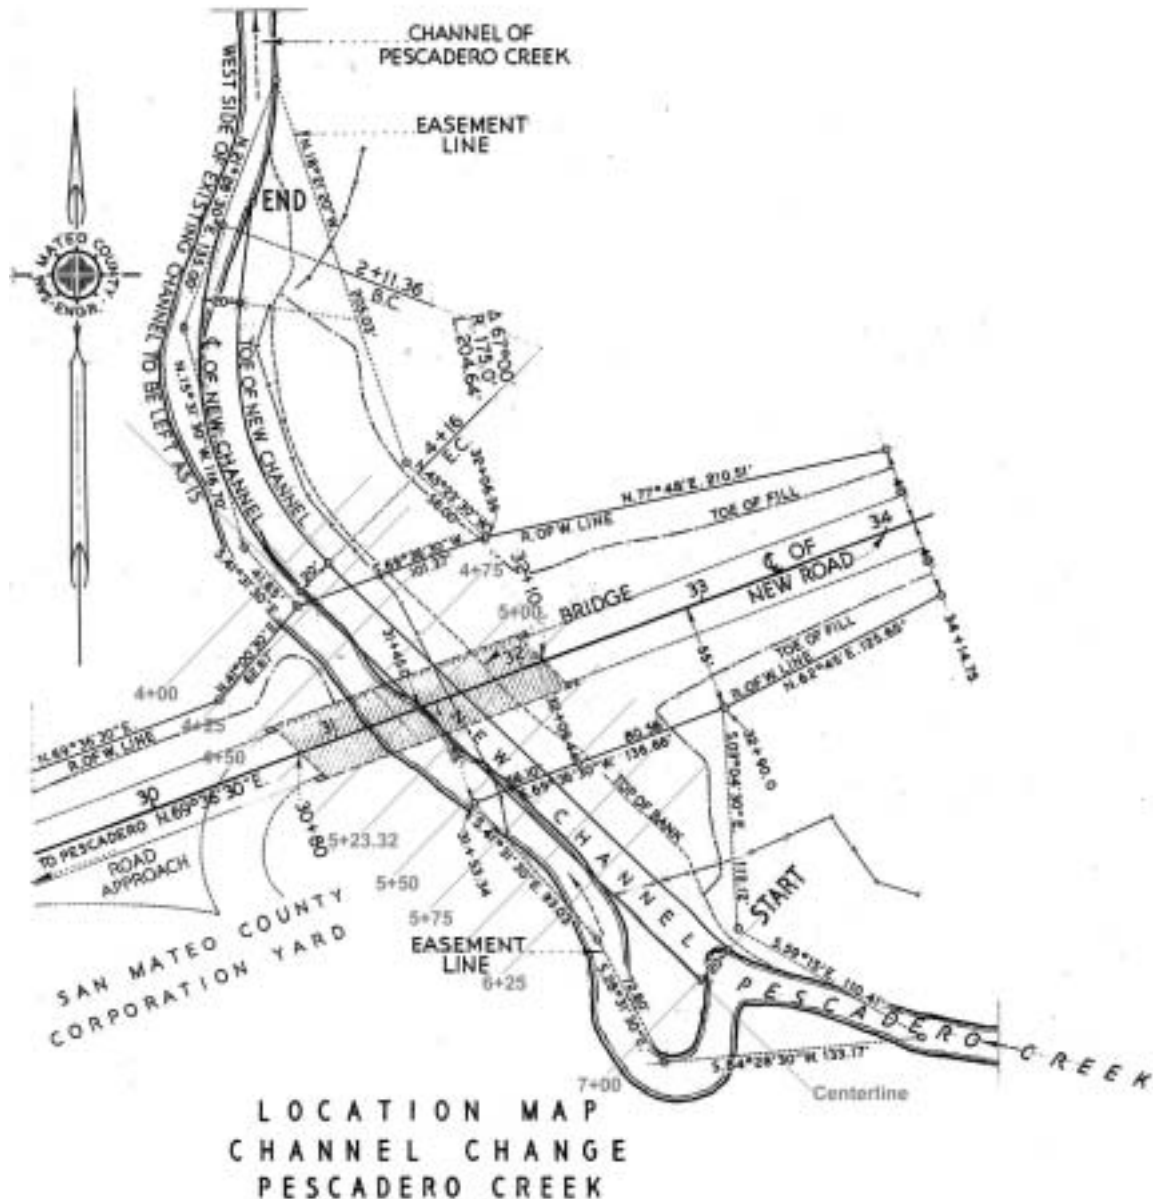
Figure 5-4: The channel change map for the Pescadero Cutoff Bridge is shown above. The flow is from the bottom of the page towards the top. The creek stationing and centerline were added by the author based on the stationing shown for the 175 foot radius turn north (downstream) of the bridge.

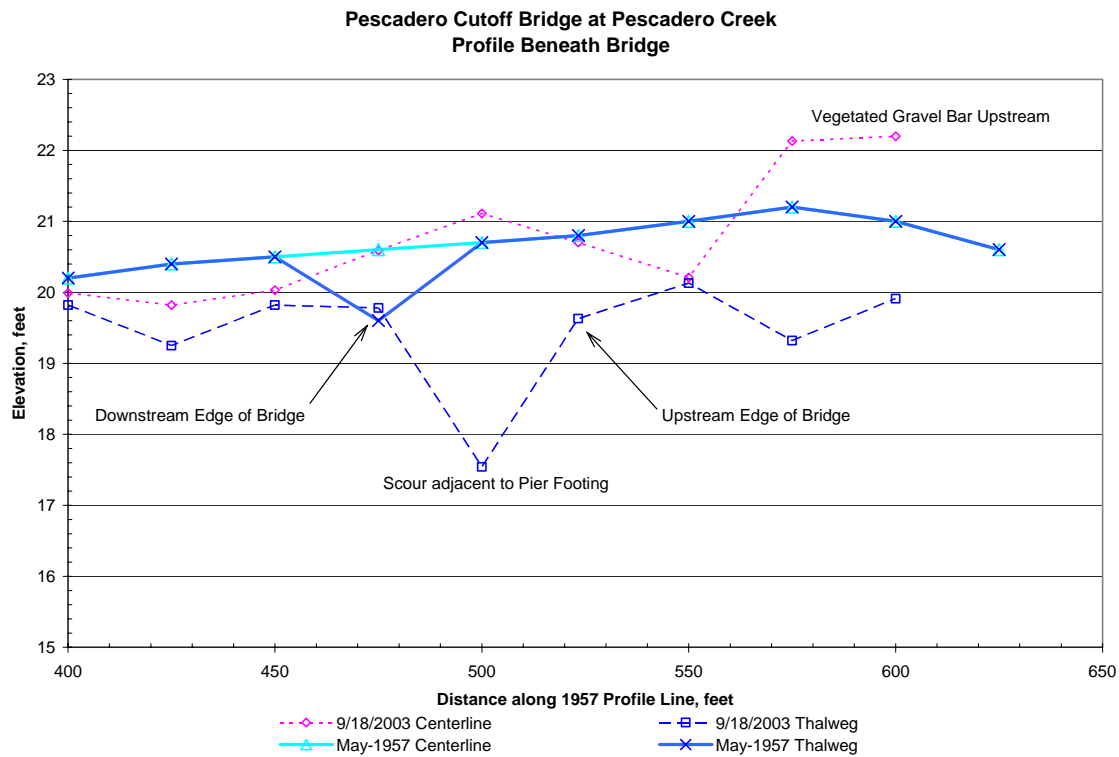
Figure 5-5: The comparison between the 1957 profile and the 2003 profile is shown.

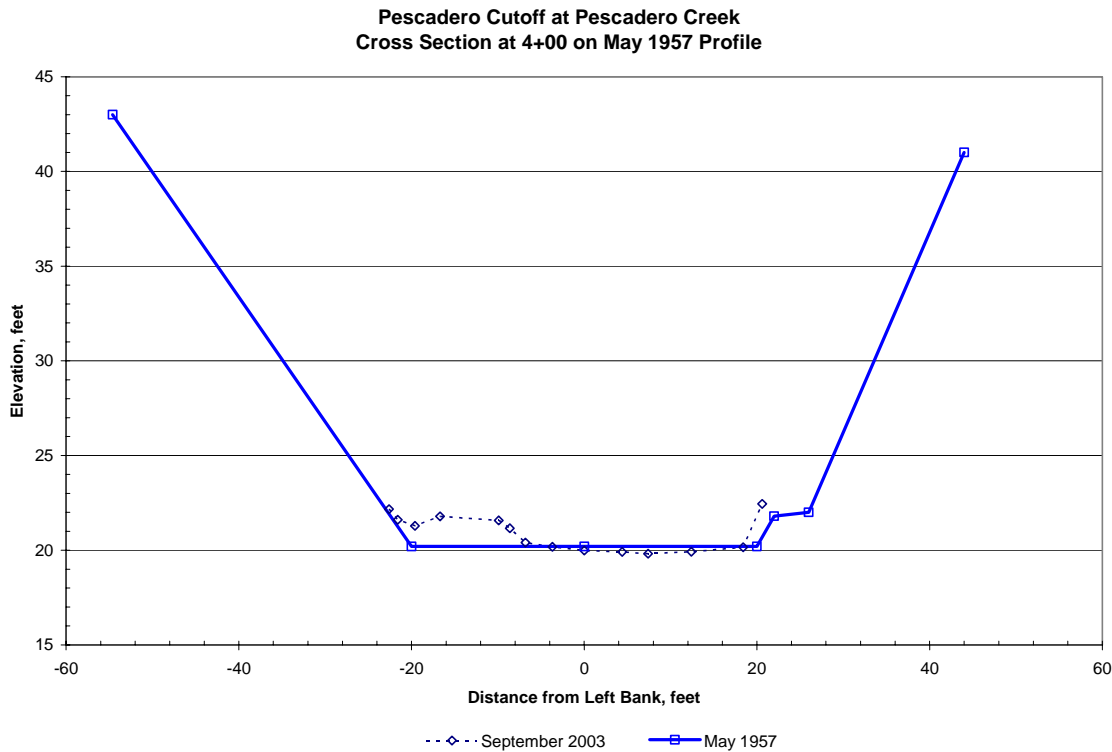
Figure 5-6: The comparison between the 1957 and 2003 surveys at station 4+00 is shown above.

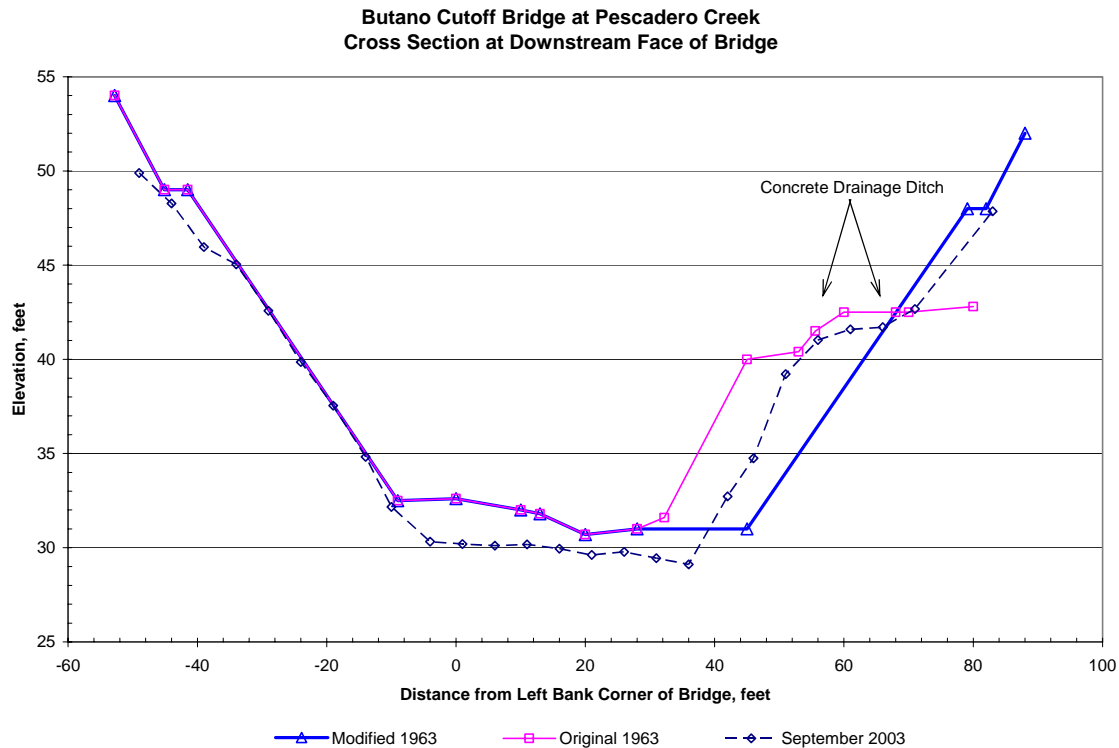
Figure 5-7: The comparison between the 1963 survey of the cross section at Station 2+20 and the 2003 survey alongside of the downstream bridge face at about Station 2+17 is shown. The 2003 cross section is about 3 feet upstream of the 1963 cross section. The original 1963 ground surface appears to be close to matching the top of the bench on the right bank suggesting that the right bank was not modified as much as suggested by the construction drawings.

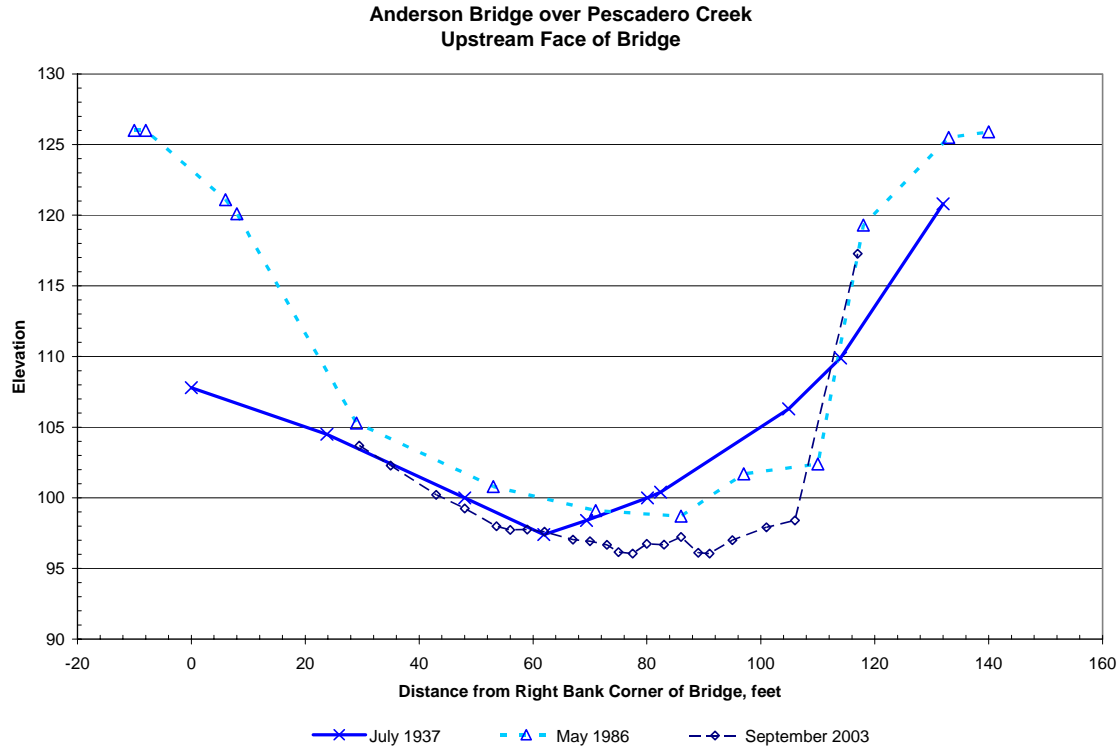
Figure 5-8: The comparison of the 1937, 1986 and 2003 cross section surveys for the upstream bridge face are shown above.

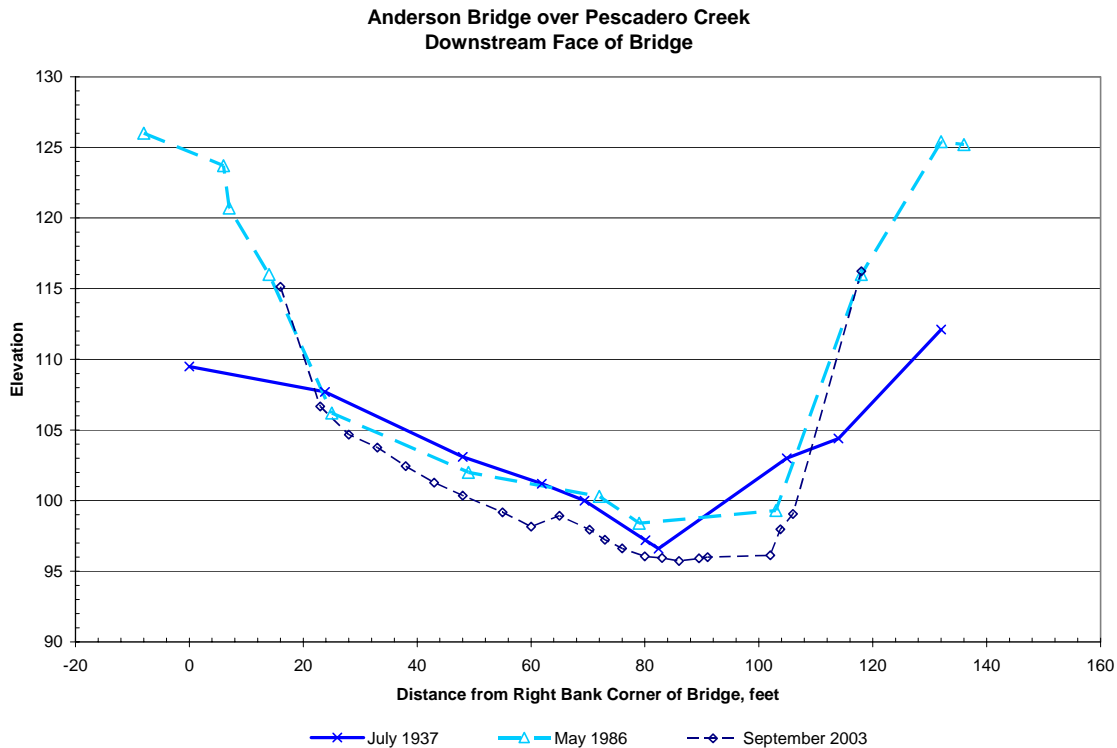
Figure 5-9: The comparison of the 1937, 1986 and 2003 cross section surveys for the downstream bridge face are shown above.

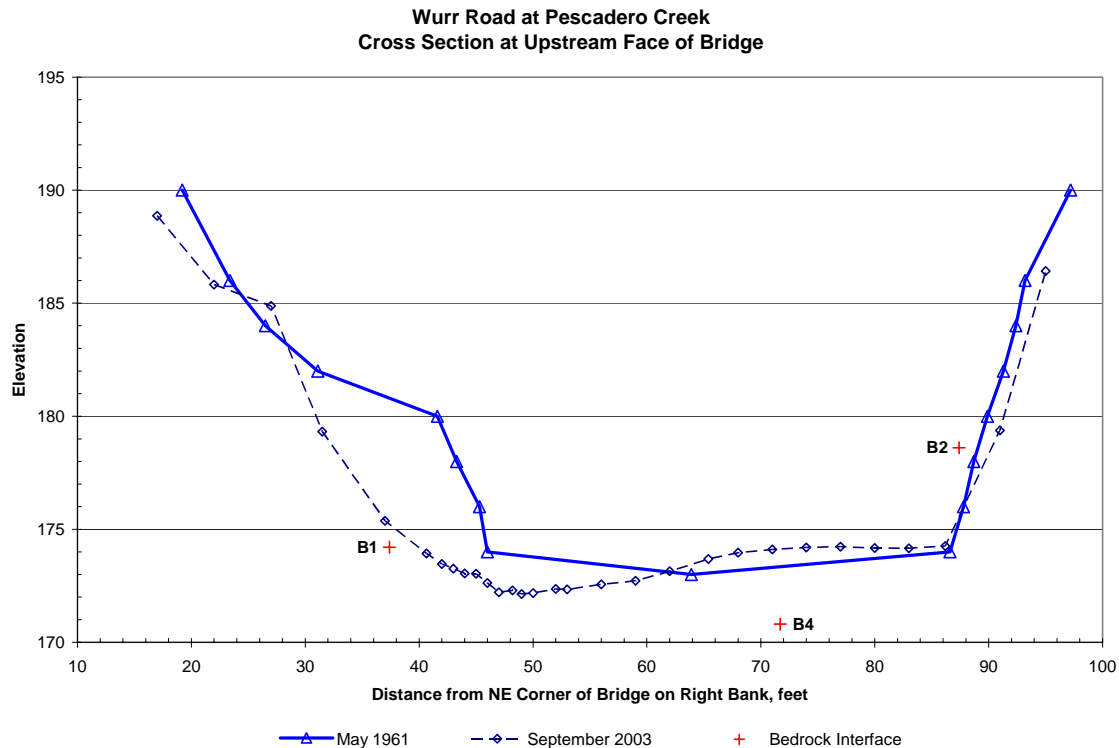
Figure 5-10: The comparison of the 1961 and 2003 channel cross sections for the upstream edge of the Wurr Road Bridge is shown above. The horizontal distance is from the right bank. The points labeled B1, B2, and B4 are the elevation of the top of bedrock shown on the boring logs. All the borings were done downstream of the cross section.

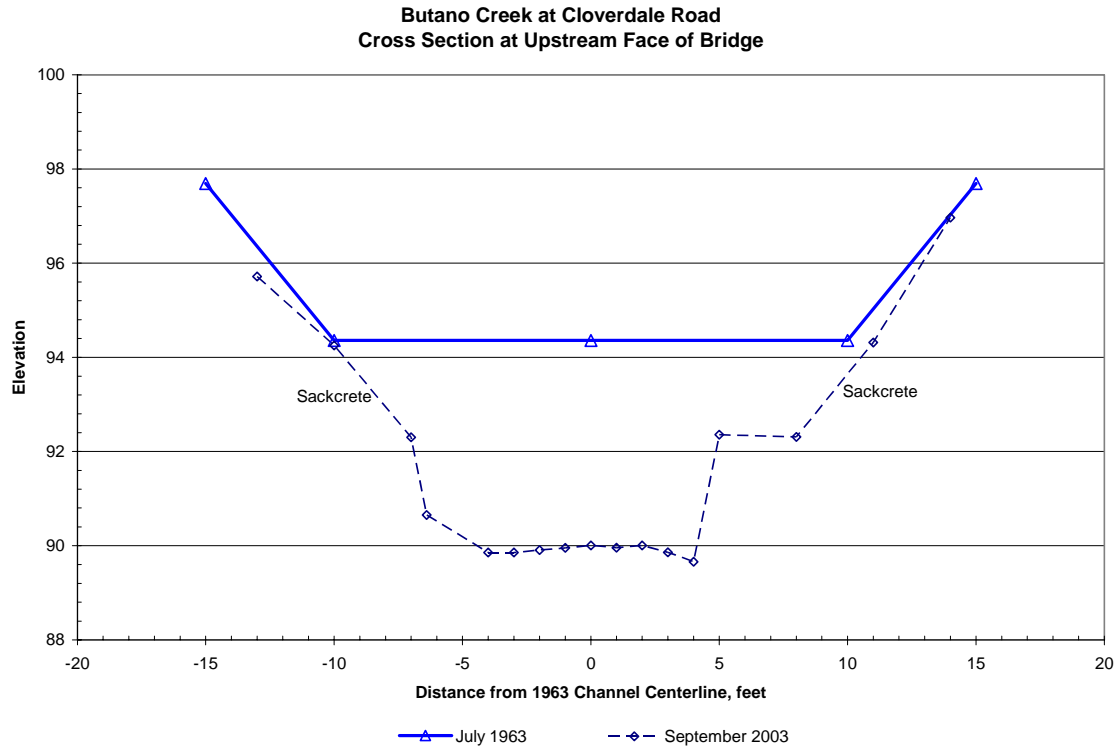
Figure 5-11: The above graph shows the channel degradation at the Cloverdale Road Bridge on Butano Creek that occurred between 1963 and 2003.

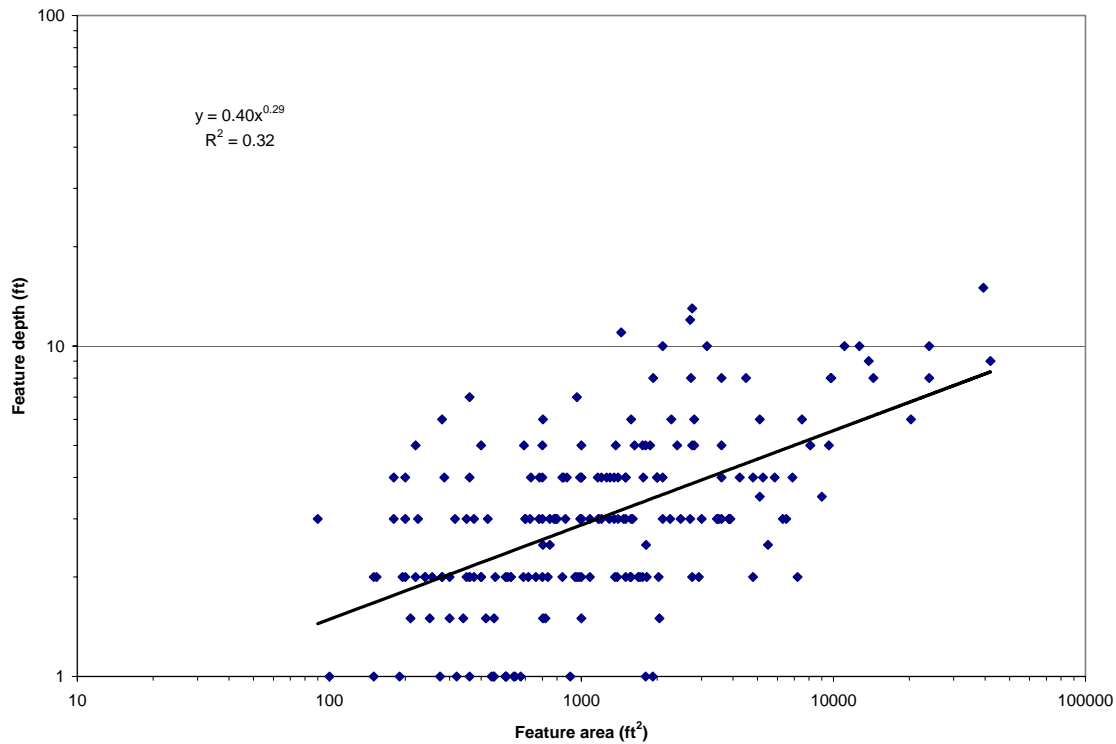
Figure 6-3: Area/depth regression for all field-inventoried debris slides

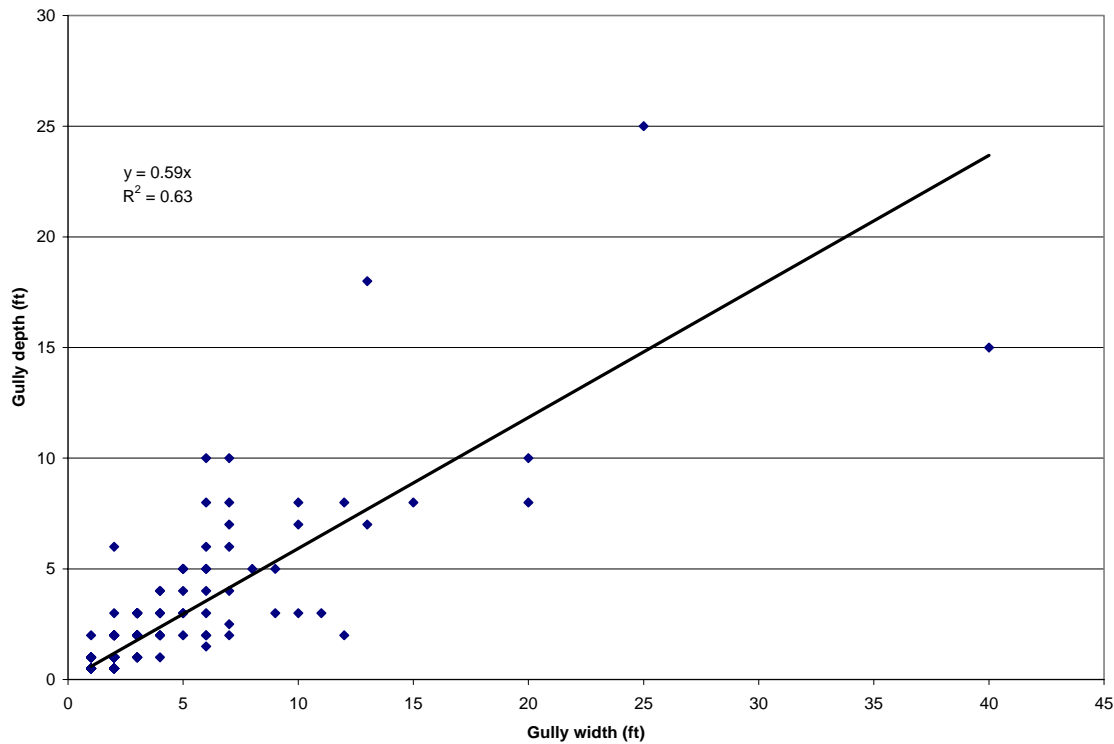
Figure 6-4: Width/depth regression for all field-inventoried gullies

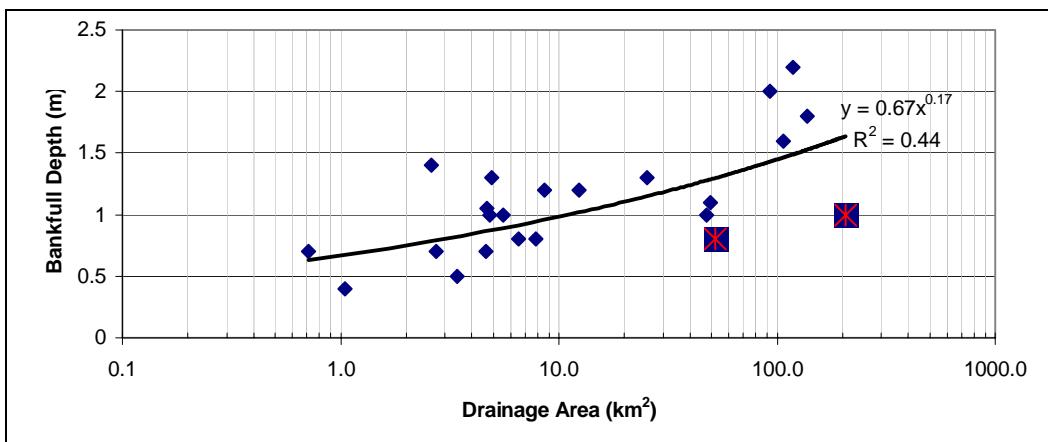
Figure 7-3: Bankfull depth as a function of drainage area. The highlighted points represent “marsh” sites in lower Pescadero and Butano Creeks where bankfull depth lies at the extreme low end of the observed distribution for larger drainage areas.

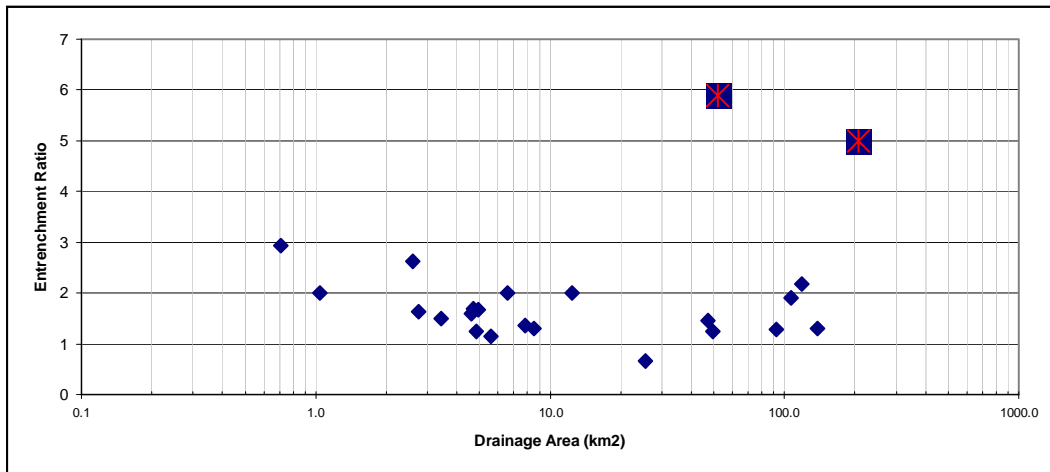
Figure 7-5: Entrenchment ratio as a function of drainage area. The highlighted points represent “marsh” sites in lower Pescadero and Butano Creeks where the entrenchment ratio lies at the extreme high end of the observed distribution for larger drainage areas.

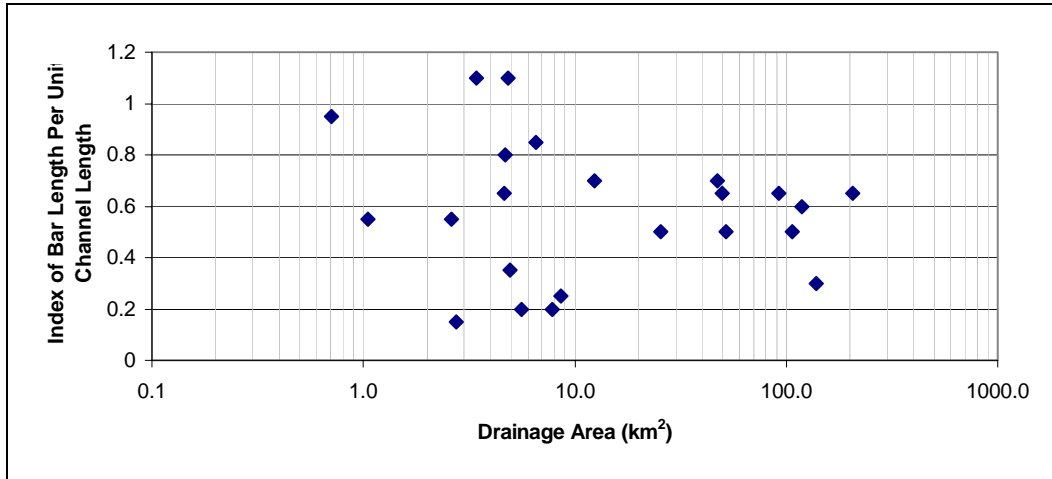
Figure 7-8: Gravel bar proportion per unit channel length.

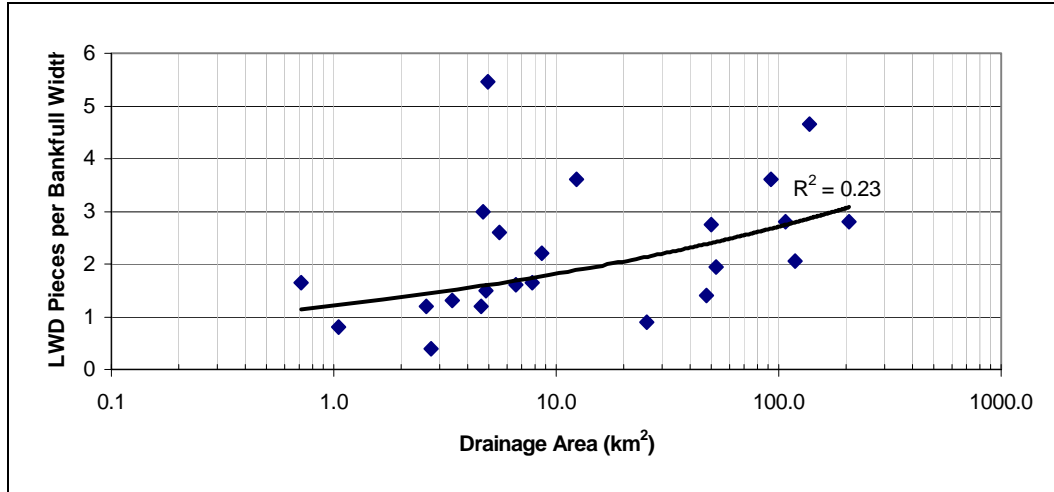
Figure 7-9: Large woody debris pieces per unit channel length as a function of drainage area. Channel length is expressed in units of bankfull width.

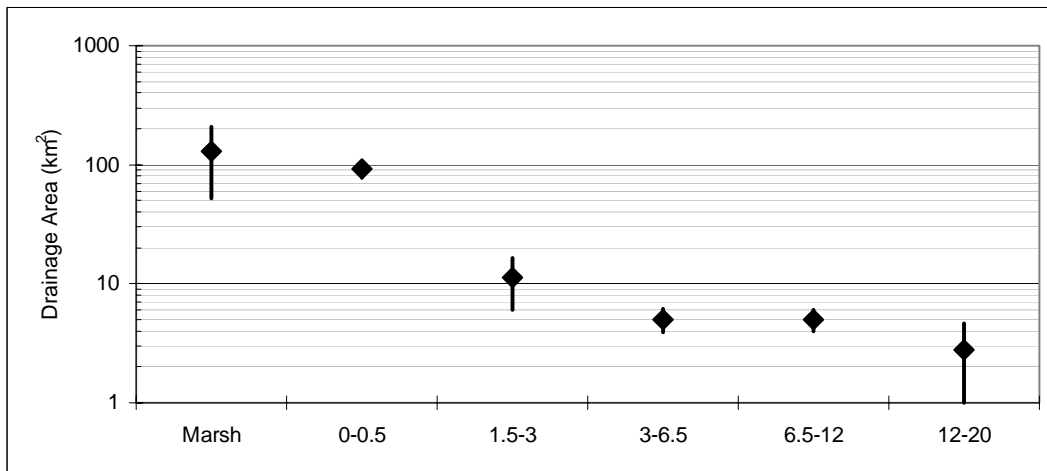
Figure 7-11: Drainage area as a function of channel slope class. The diamond indicates the mean value; the line represents the range of one standard error around the mean.

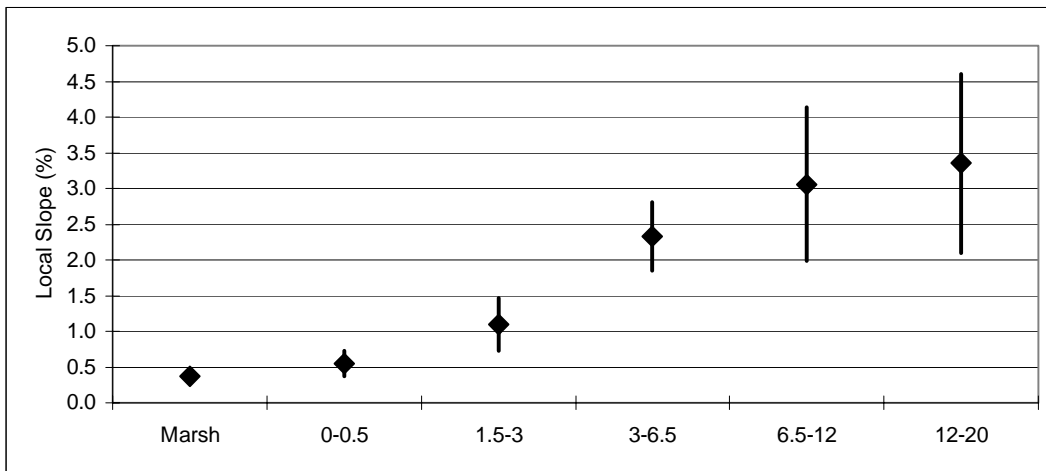
Figure 7-12: Local channel slope measured in the field as a function of channel slope class. The diamond indicates the mean value; the line represents the range of one standard error around the mean.

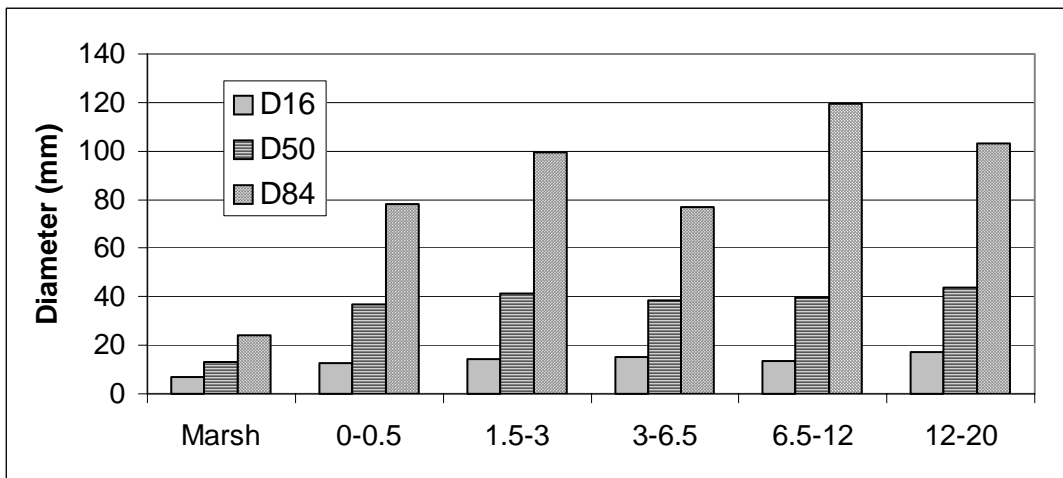
Figure 7-13: Mean values of D16, D50 and D84 as a function of channel slope class.

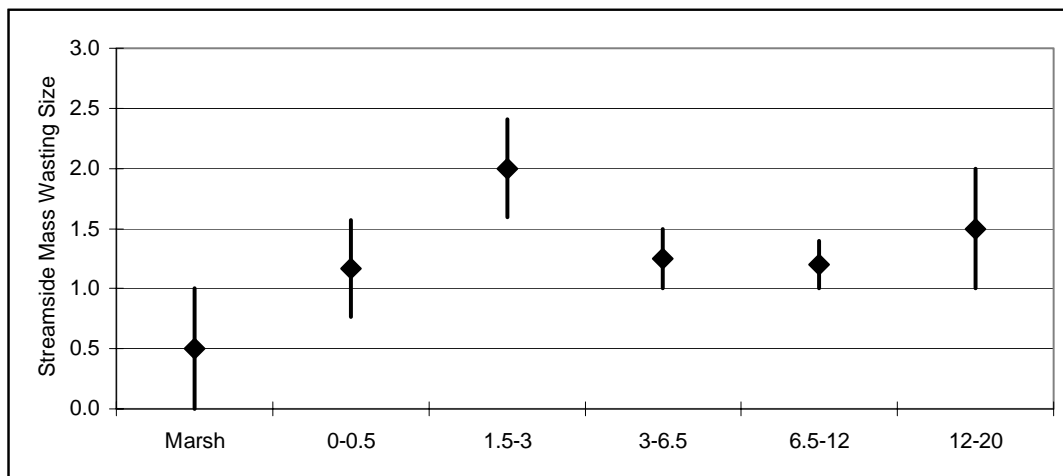
Figure 7-18: Size of streamside mass wasting (SSMW) features in stream channels as a function of channel slope class. A value of 1 indicates the scale of SSMW features are $< 5x$ bank height, a value of 2 indicates that SSMW features are $5-10x$ bank height. The diamond indicates the mean value; the line represents the range of one standard error around the mean.

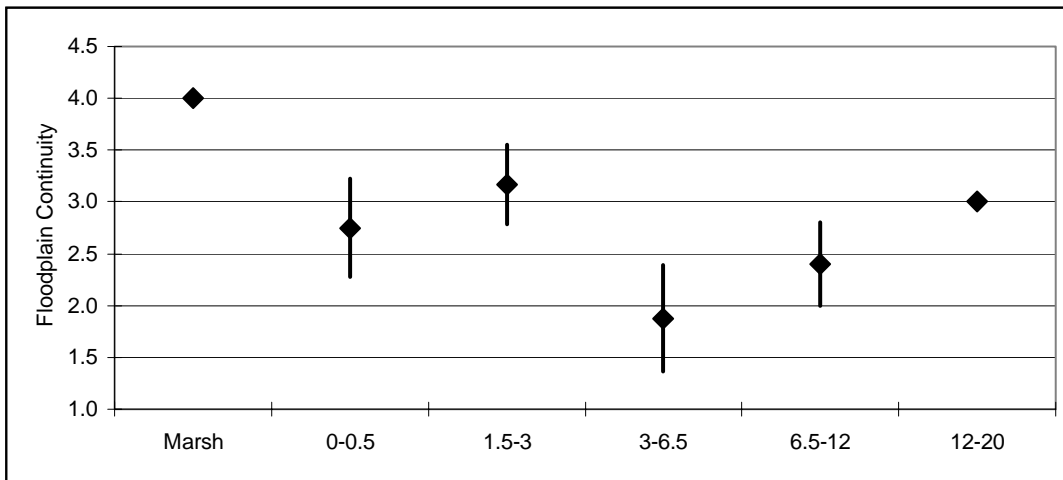
Figure 7-19: Floodplain continuity in stream channels as a function of channel slope class. A value of 4 indicates continuous floodplain in the reach, a value of 3 indicates discontinuous floodplain in the reach, and a value of 2 indicates terraces with no evidence of recent overbank flow. The diamond indicates the mean value; the line represents the range of one standard error around the mean.
